PHOTOGRAPHIC INTERPRETATION REPORT

ICBM COMPLEX, PERM, USSR PROBABLE LAUNCH SITE GI3

Perm ICBM Complex, Probable Launch Site G13*

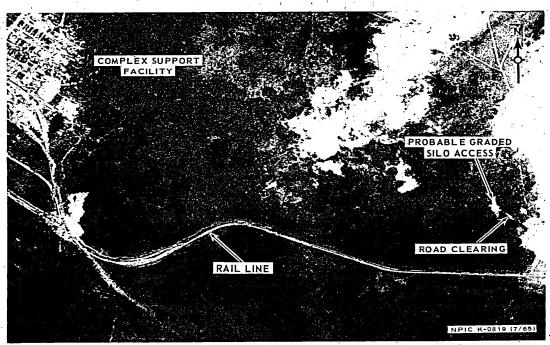
This newly identified site contains a probable characteristic graded earthen silo access. The access is parallel to those at the other single-silo sites at this complex. A clearing for a road leads from the complex main road to the site. Poor quality, non-stereo photography precludes additional details.
